Macroinvertebrate and Water Quality Survey of Smelt Brook

**Macroinvertebrate and Water Quality Survey of
Smelt Brook. Braintree Massachusetts March 27,
2009**

By: Rohan Aggarwal, Eleanor Mees, Jackie Flynn, Joseph Folan,
Dylan Mitchell, Kasey Nolan, Bridget Burke

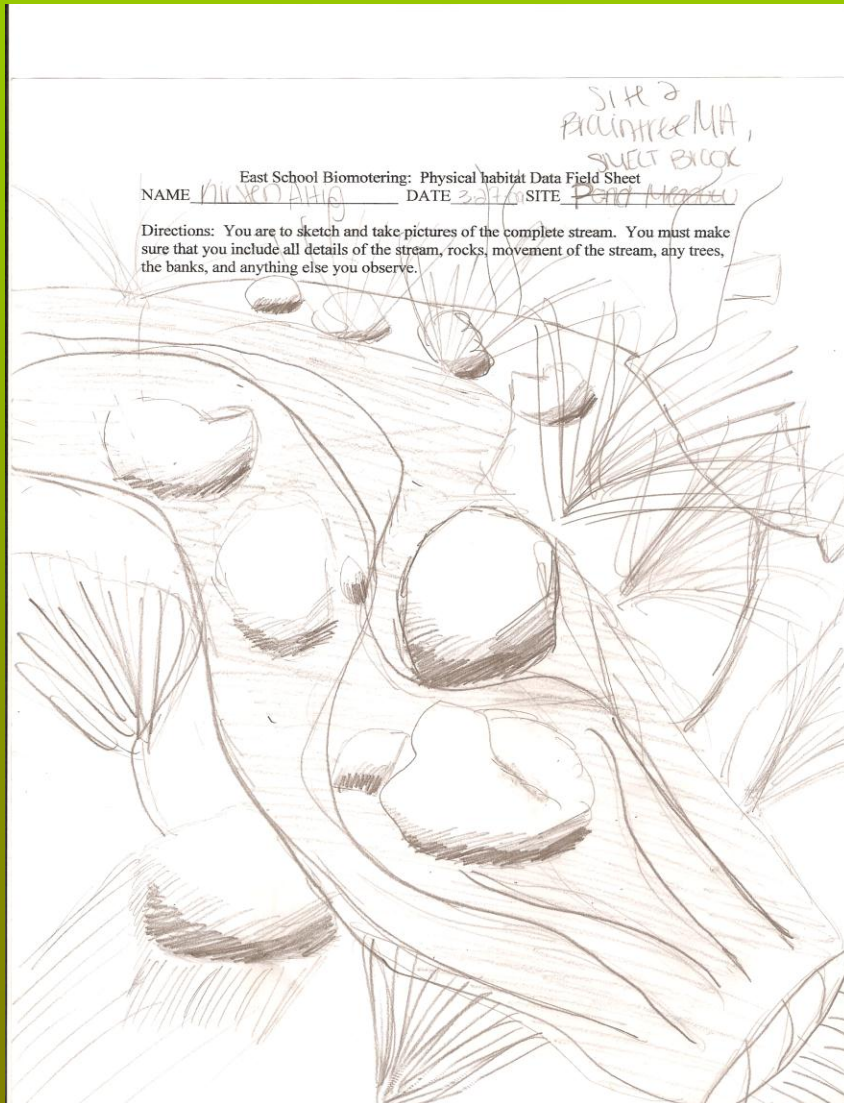
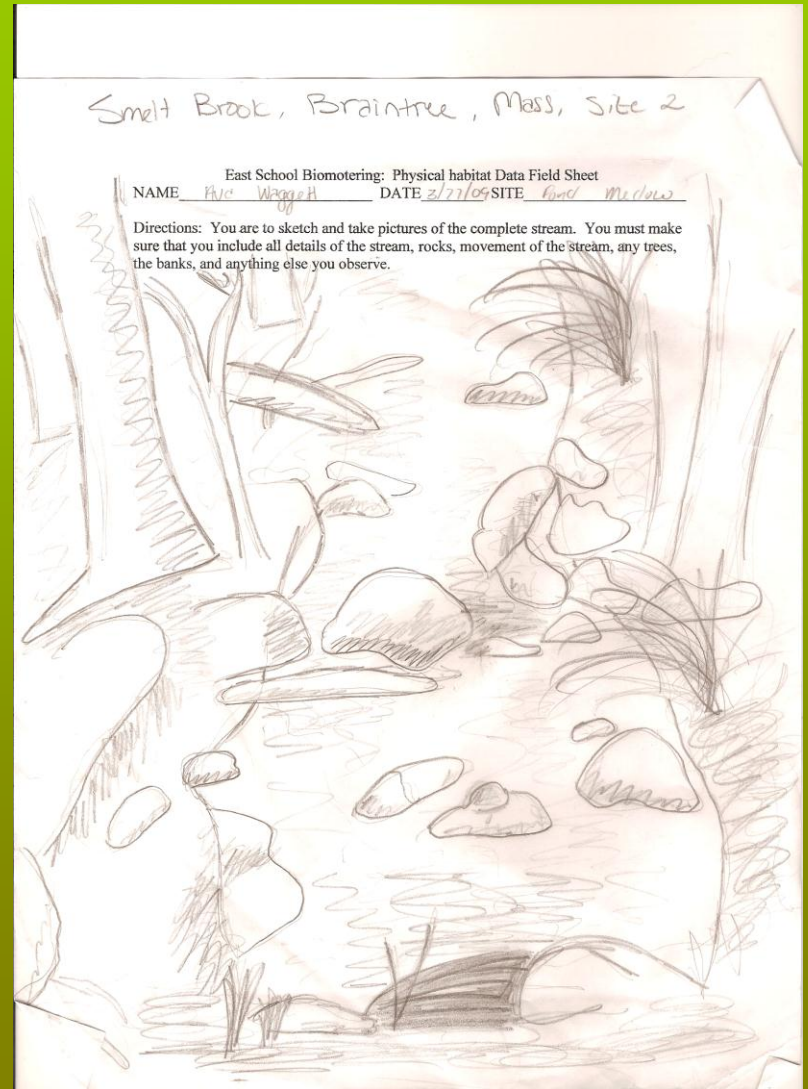
Drawings of the Site

- 1. Lots of boulders in the stream
- 2. Major ripple areas
- 3. Both banks covered with trees and brush
- 4. Water was clear
- 5. Many broken branches in the water

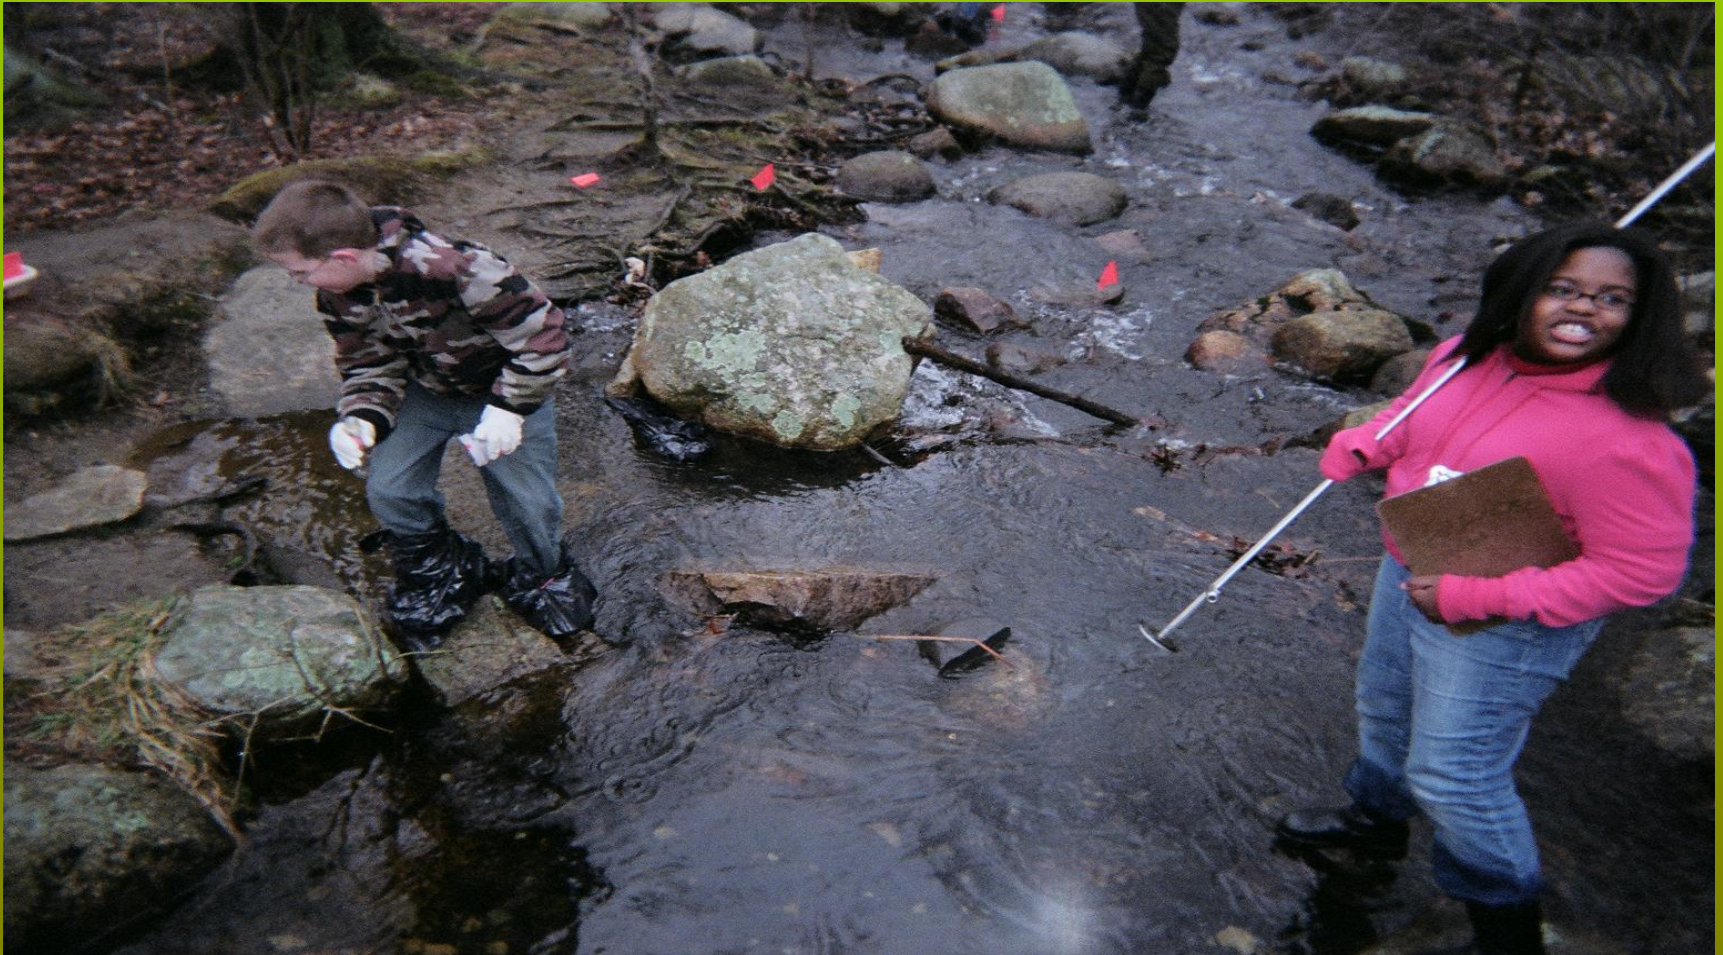
Measuring River Flow

Segment #	Segment Distance	Depth A	Depth B	Average Depth	Area of Segment (ft ²)	Average Flow At 0.6 from Surface	Flow ft ³ /sec (CFS)
1	2 ft.	20 Cm	8 cm	14 cm	28 ft ²	.69	19.32
2	2 ft.	30 cm	8 cm	19 cm	38 ft ²	.81	30.78
3	2ft.	13 cm	12 cm	12.5 cm	25 ft ²	.78	19.5
4	2 ft.	24 cm	20 cm	22 cm	44 ft ²	.47	20.68

Q= Total Discharge	90.28	Q in CFS	90.28
		Q in L/sec	2556.72

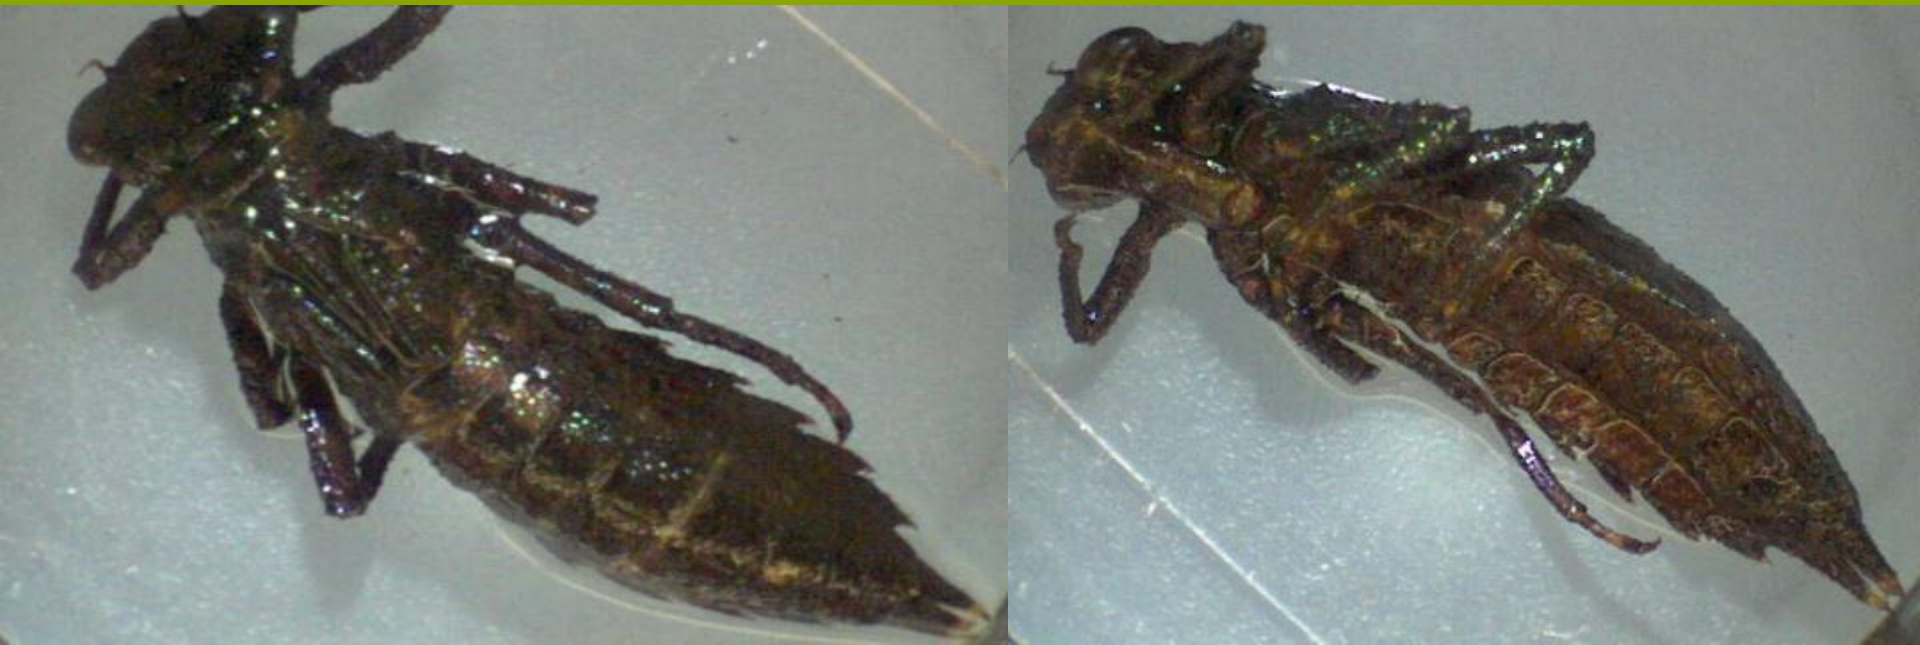
Odonata “Darner Dragonfly”

This bug is somewhat sensitive to pollution, so finding these bugs are encouraging to the health of the river. They have 1 pair of wings, 6 legs, and 2 short antennae.

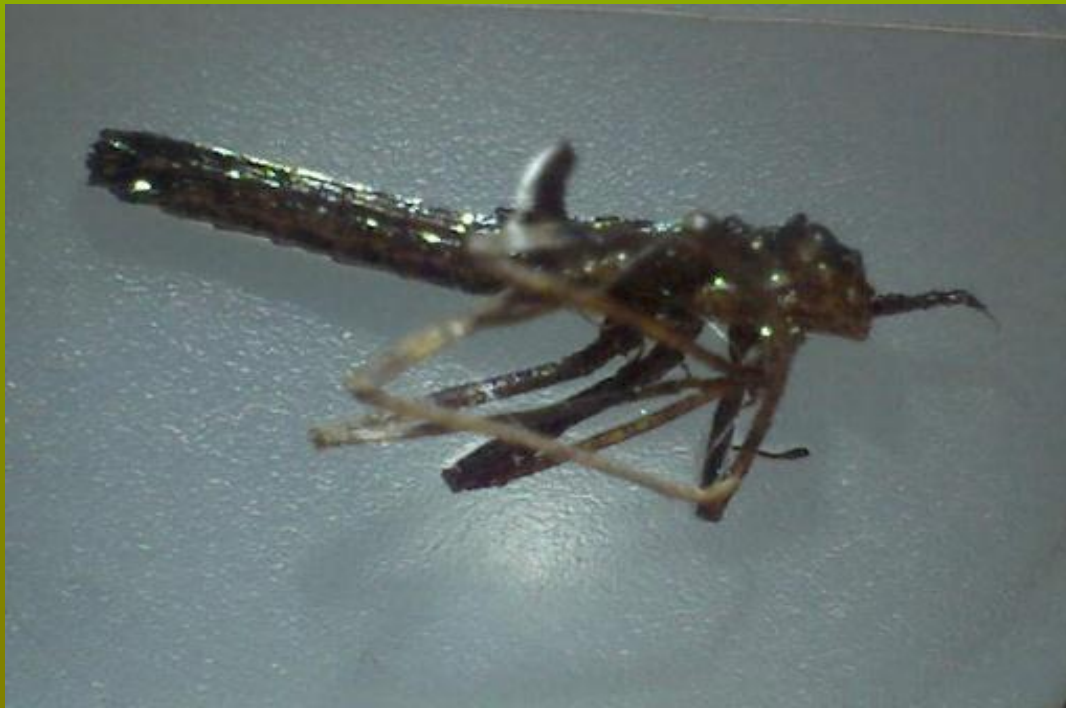
Plecoptera Stonefly Nymph

Stoneflies are Group 1 (sensitive) bugs. They are prey to fish, water insects, and crayfish. They live on/under rocks and are usually found in streams or rivers rarely in a pond or lake.

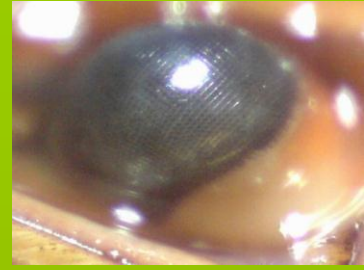
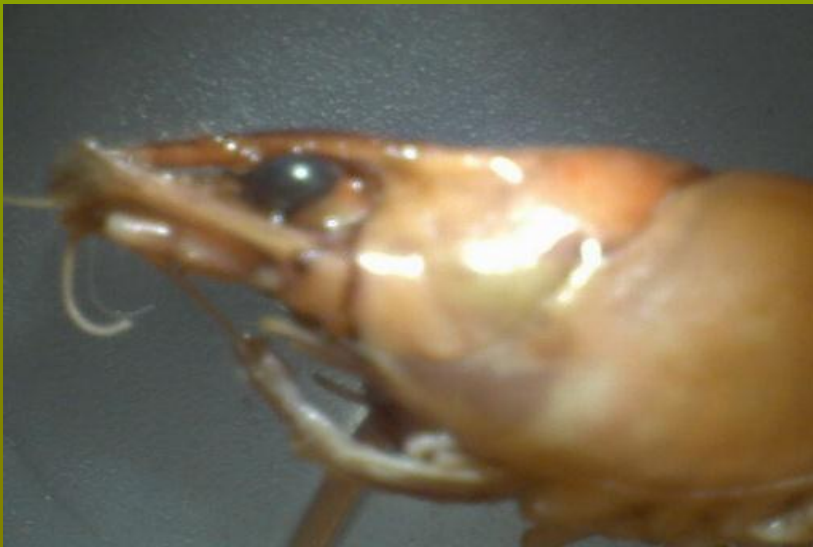
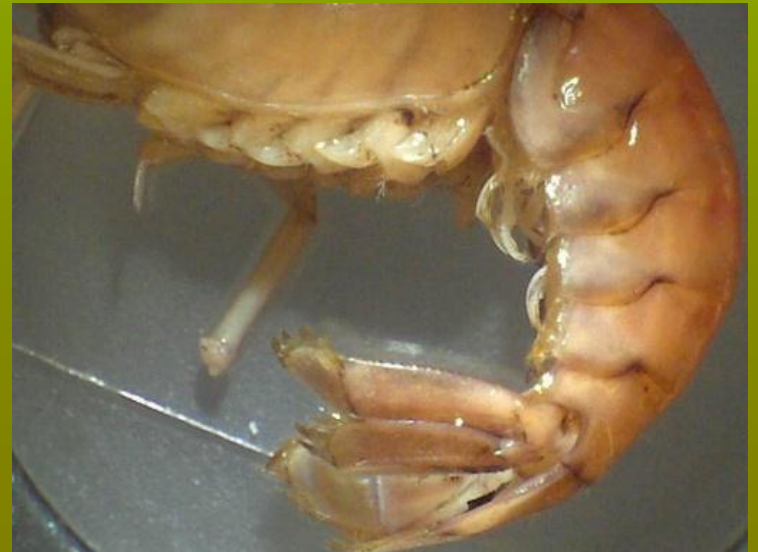
Crustacea Crayfish

- Crayfish are somewhat sensitive to pollution. They have an orange pigment. They have eight legs and one tail. They have two whiskers.

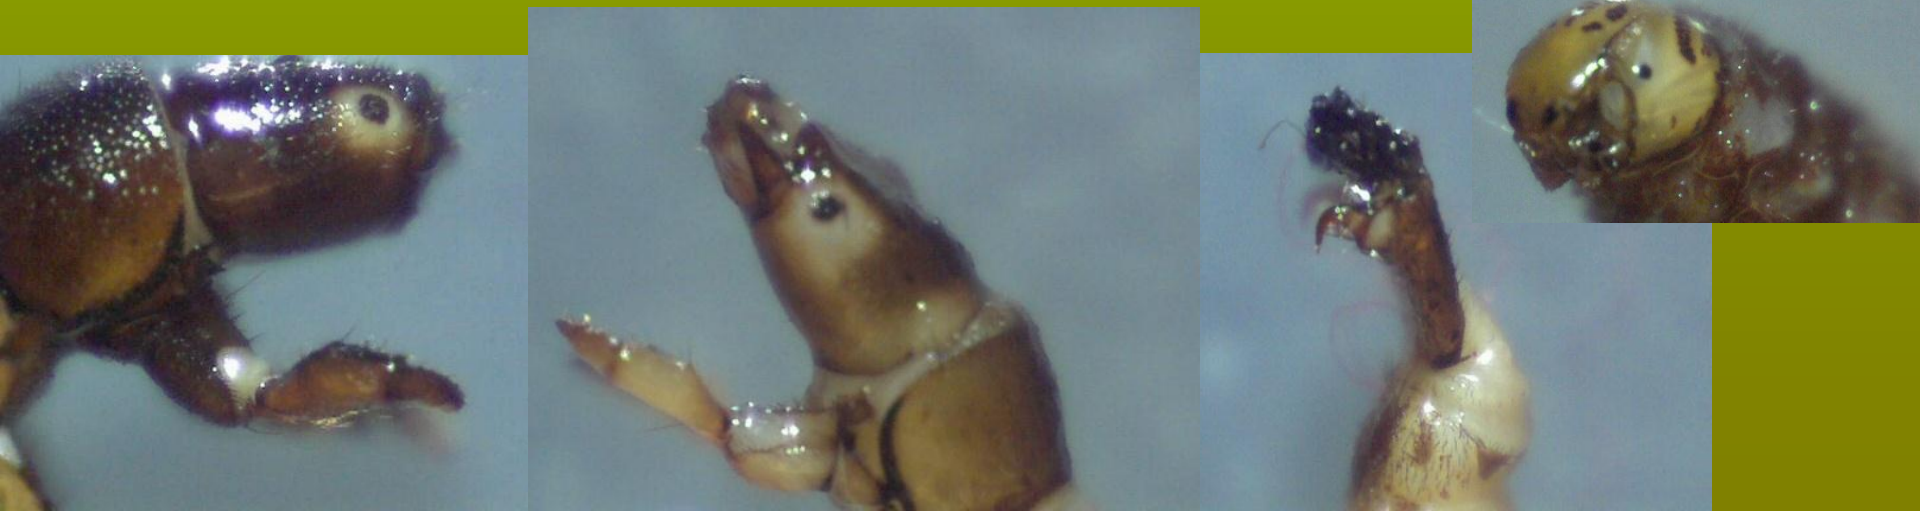
Trichoptera Caddisfly Larvae

Trichoptera are the group 1 sensitive bugs. They have big eyes and a spiky tail. They have hair on their back. There are many types of caddisflies and they are of all different shapes.

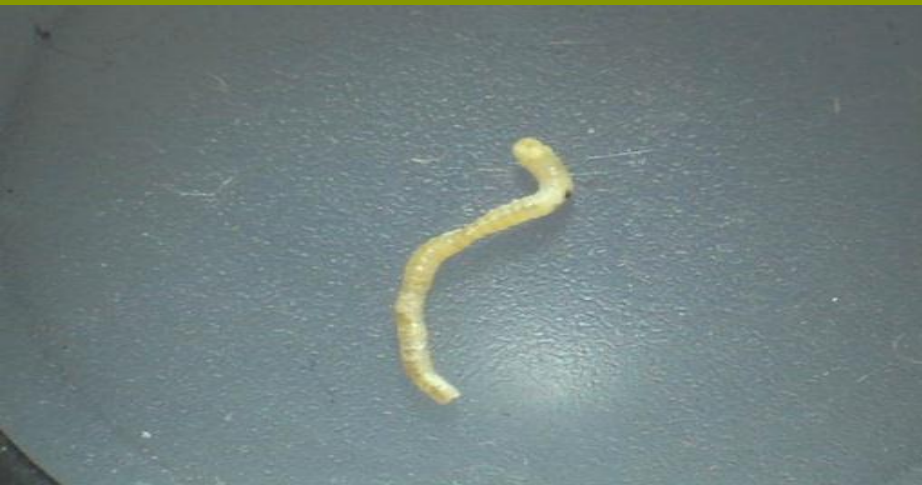
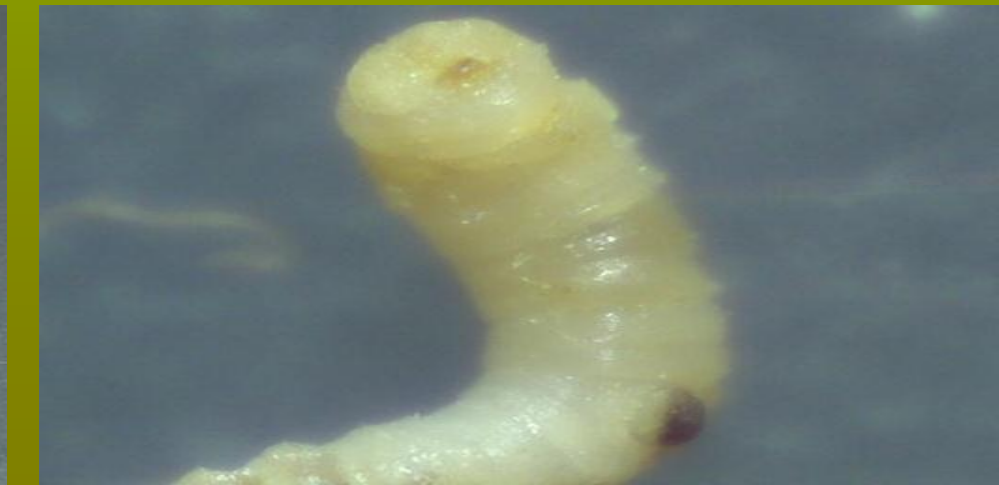
Aquatic Worms

Aquatic worms are group 3 bugs. That means that they are tolerant and can live in polluted water. This news is neither good or bad for the health of the river. They are common water insects and look a lot like worms.

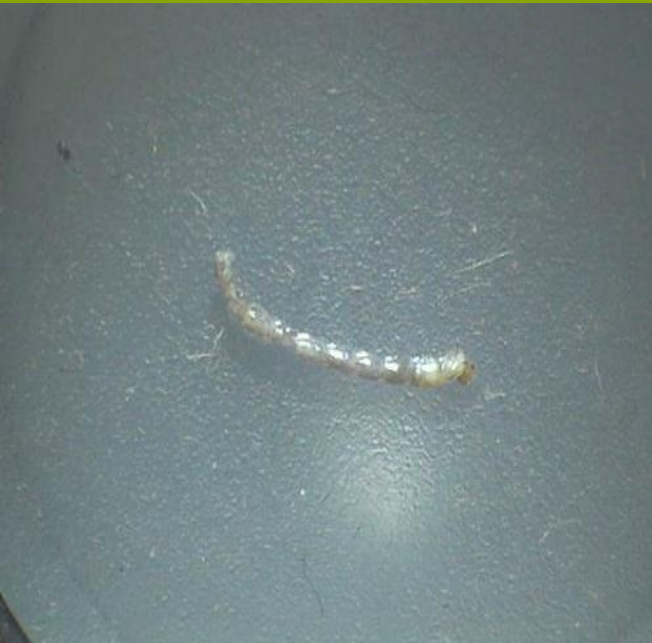
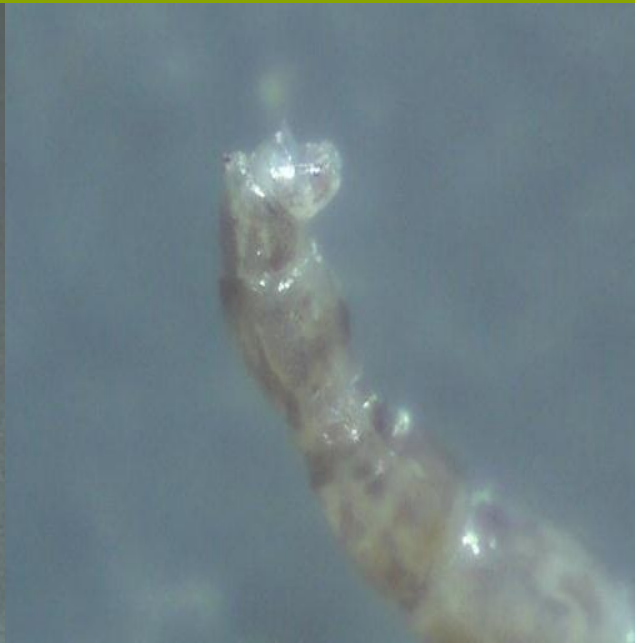
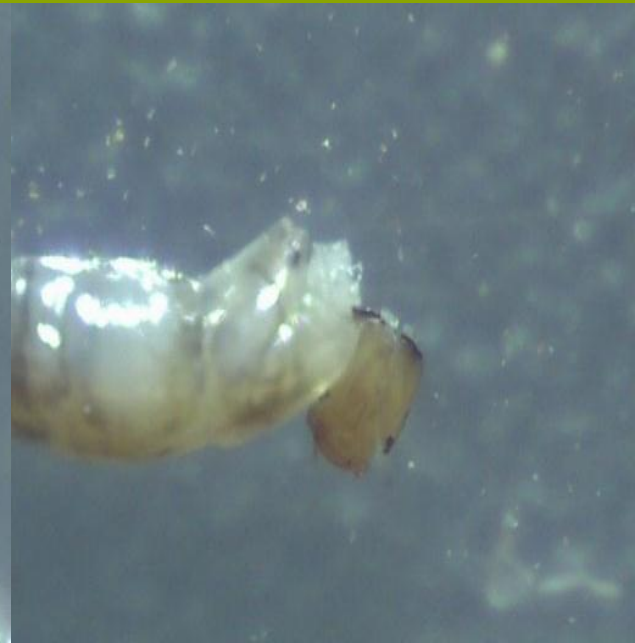
Biting Midge

Midges are group 3 bugs. Their body is segmented in many parts. It also has smooth skin. Even though they are small they still have the capability to bite you.

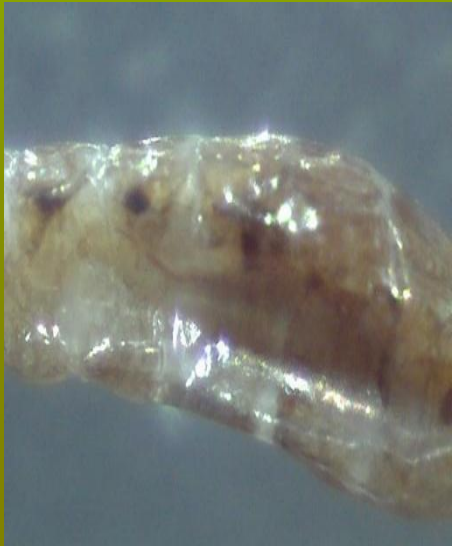
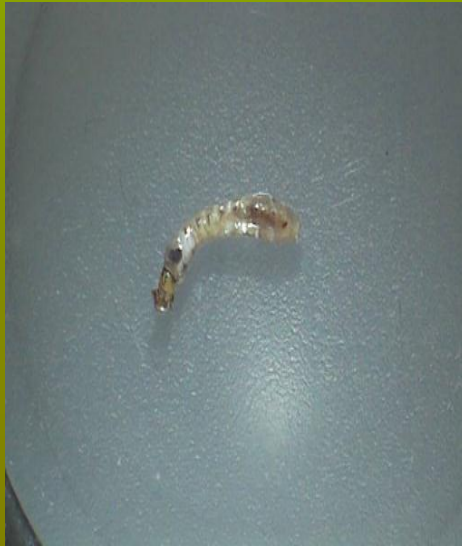
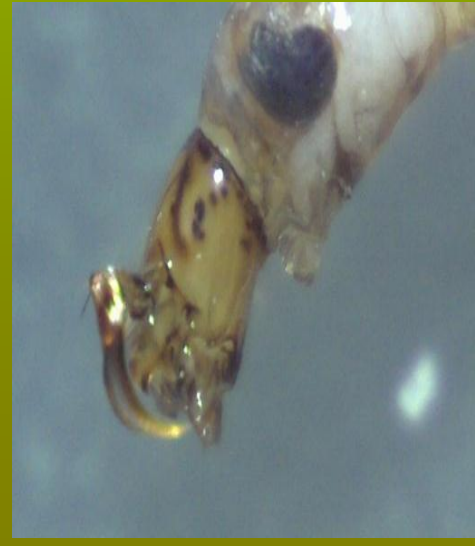
Diptera Black Fly Midge

This bug is usually 6 mm long. Found on rocks and in fast flowing rivers/streams. It has a smooth body and a sharp front claw. When it grows up it grows wings.

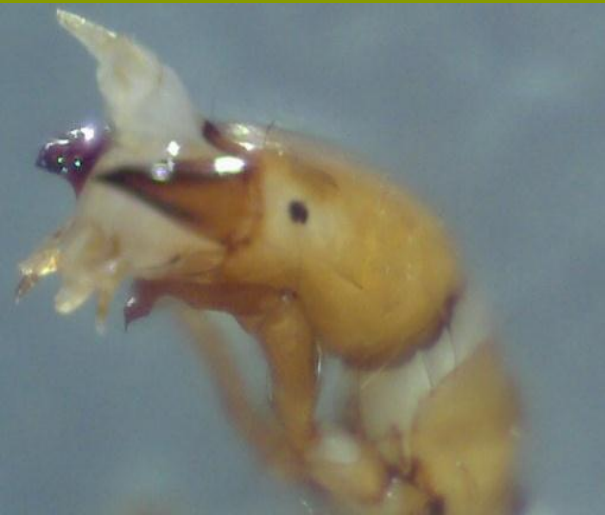
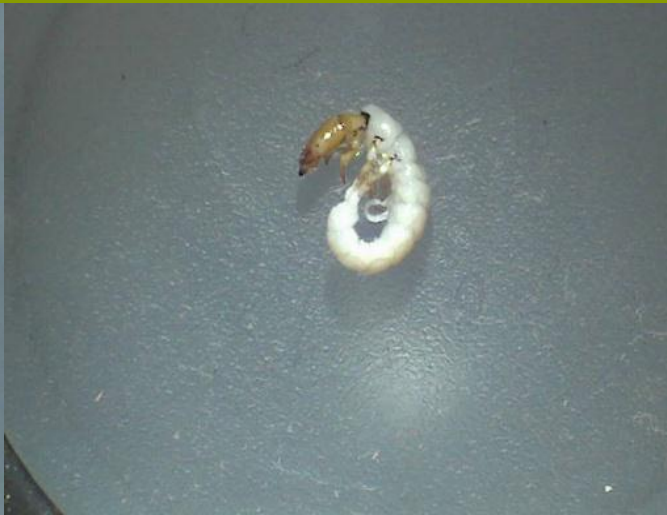
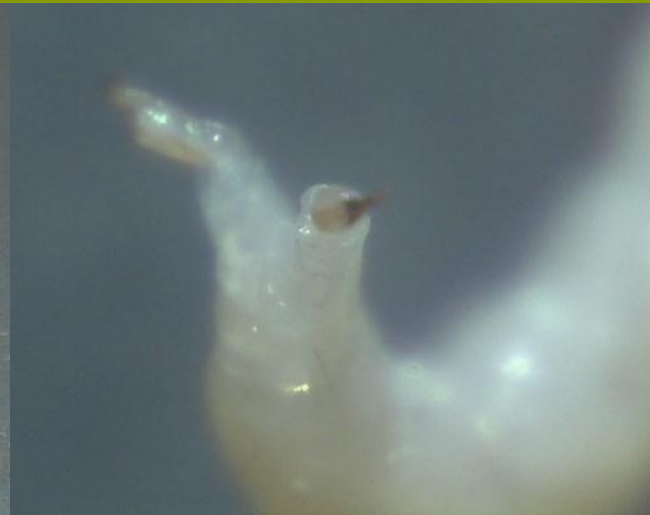
Trichoptera Finger-Net Caddisfly

These bugs are sensitive bugs. These bugs have a white pigment and have brown heads. These bugs have a labrum which is made out of membrane.

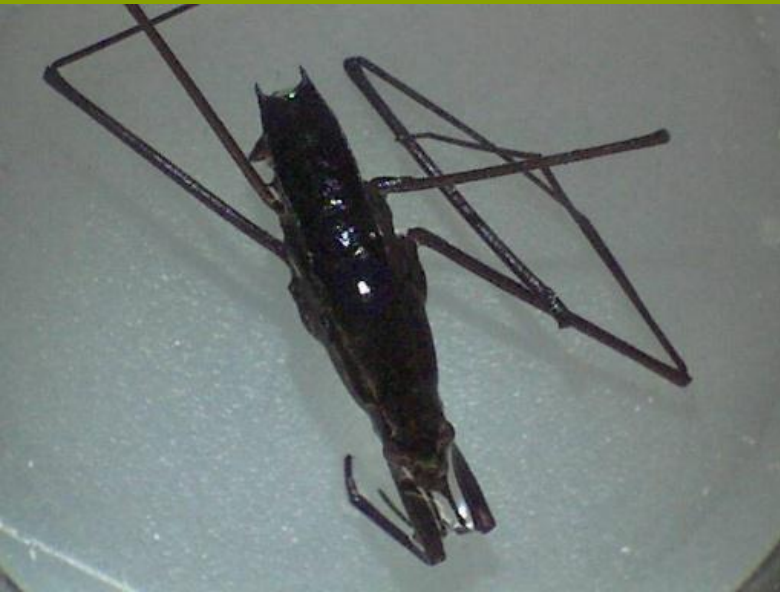
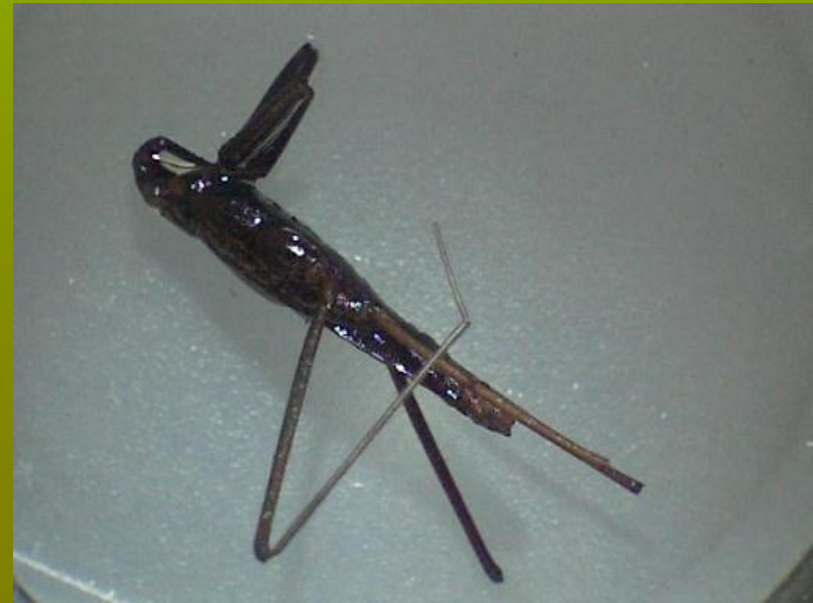
Hemiptera Water Strider

Water Striders are of the tolerant group.
These bugs can live in polluted water.
They skip on top of the water and are black.
They look a lot like spiders.

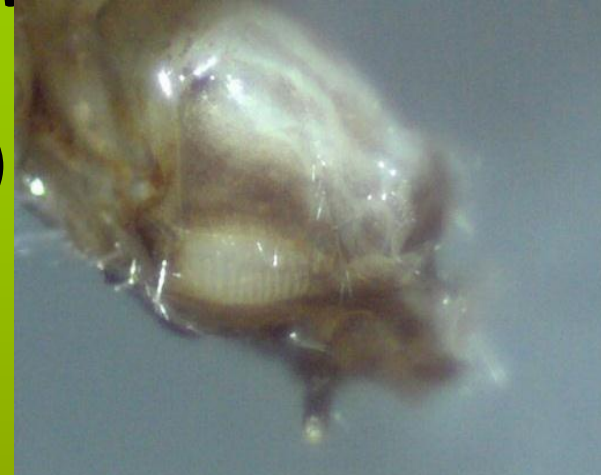
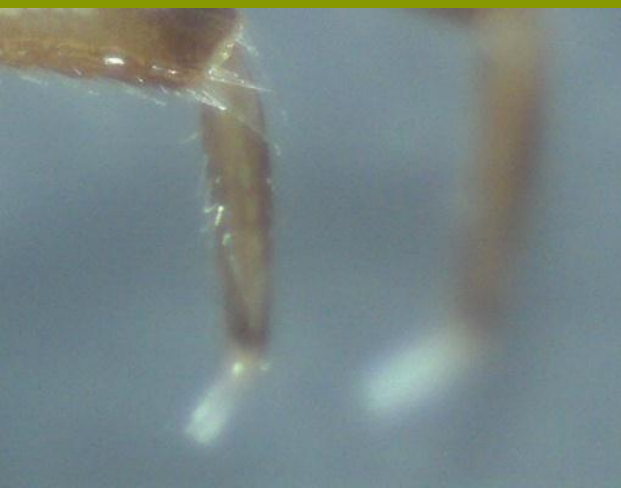
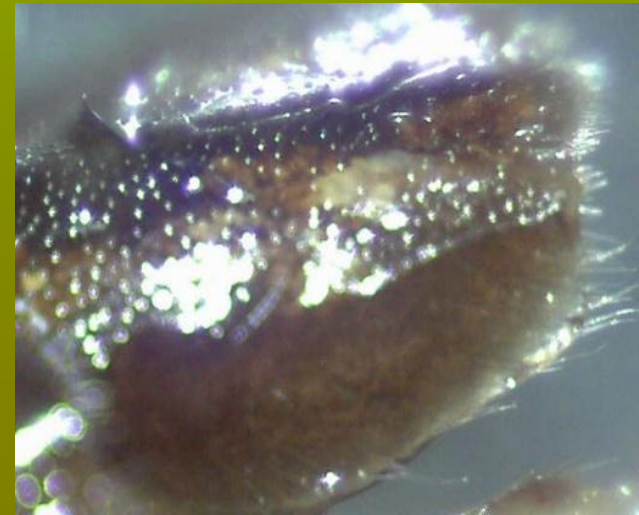
Plecoptera Mayfly Nymphs

Mayflies are group 1 (sensitive) bugs. They have 3 tails, 1 claw abdominal gills, short antenna, and 1 set of wings.

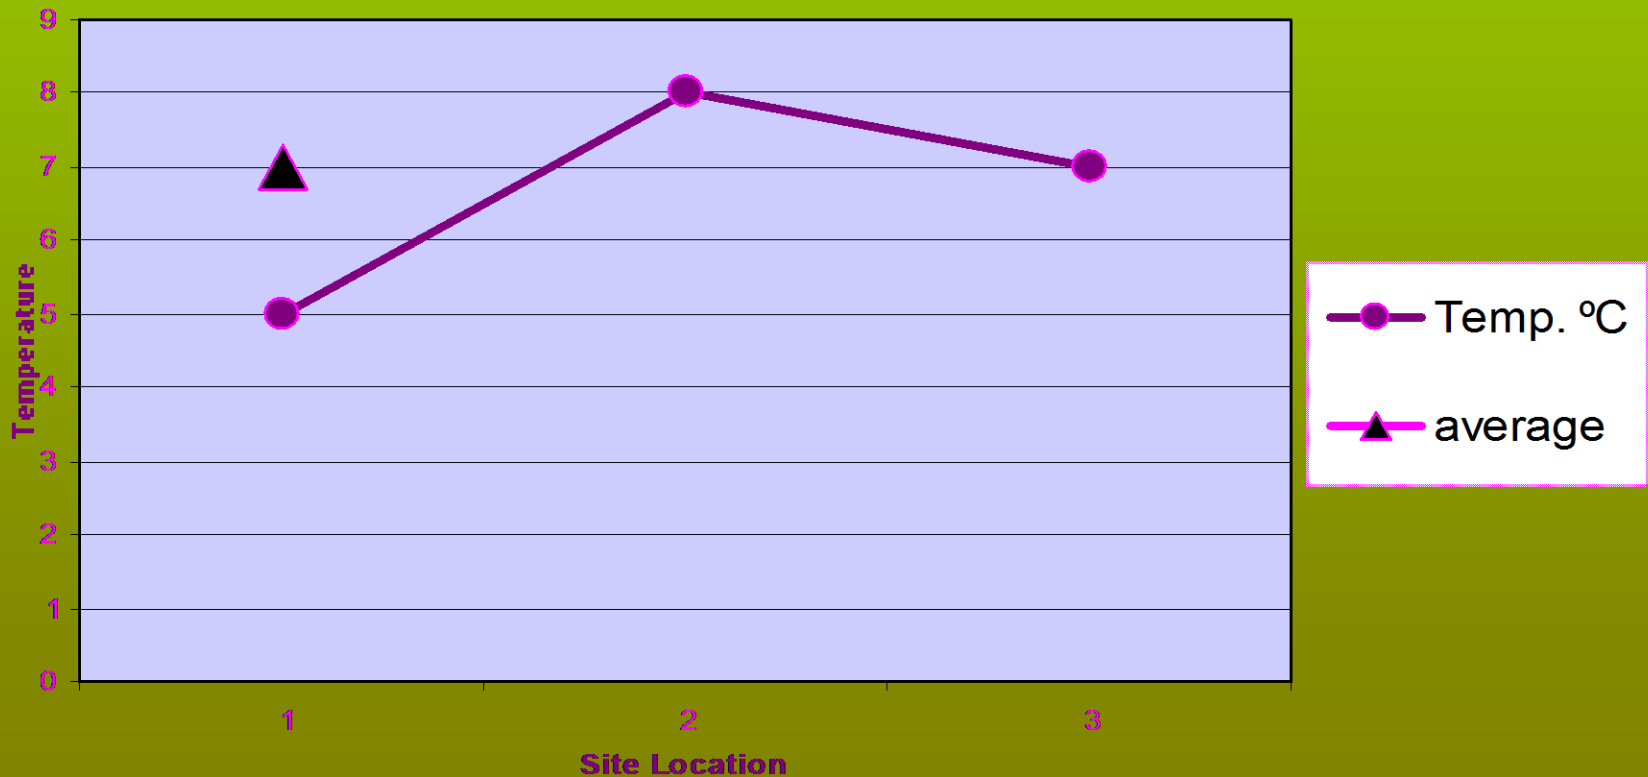
Temperature at Smelt Brook March 27, 2009

We took measurements from the water at Smelt Brook. For our first sight, the length bank to bank was 9 feet, 9 inches. The high water level was 34 centimeters. For our second sight, we measured that the length was 6 feet, 4 inches and the high water level was 30 centimeters. For our third and final sight, the length was 6 feet, 4 inches, and the high water level was 37 centimeters. The average length was 8 feet. The average high water level was 33 centimeters. The average temperature for the brook was 42°F or 7°C.
